Rain Impact Assessment of
Advanced Thermal Protection System Materials
Phase I Test Results

R. M. COOPER
Materials Sciences Laboratory
Laboratory Operations
The Aerospace Corporation
El Segundo, CA 90245

5 September 1985

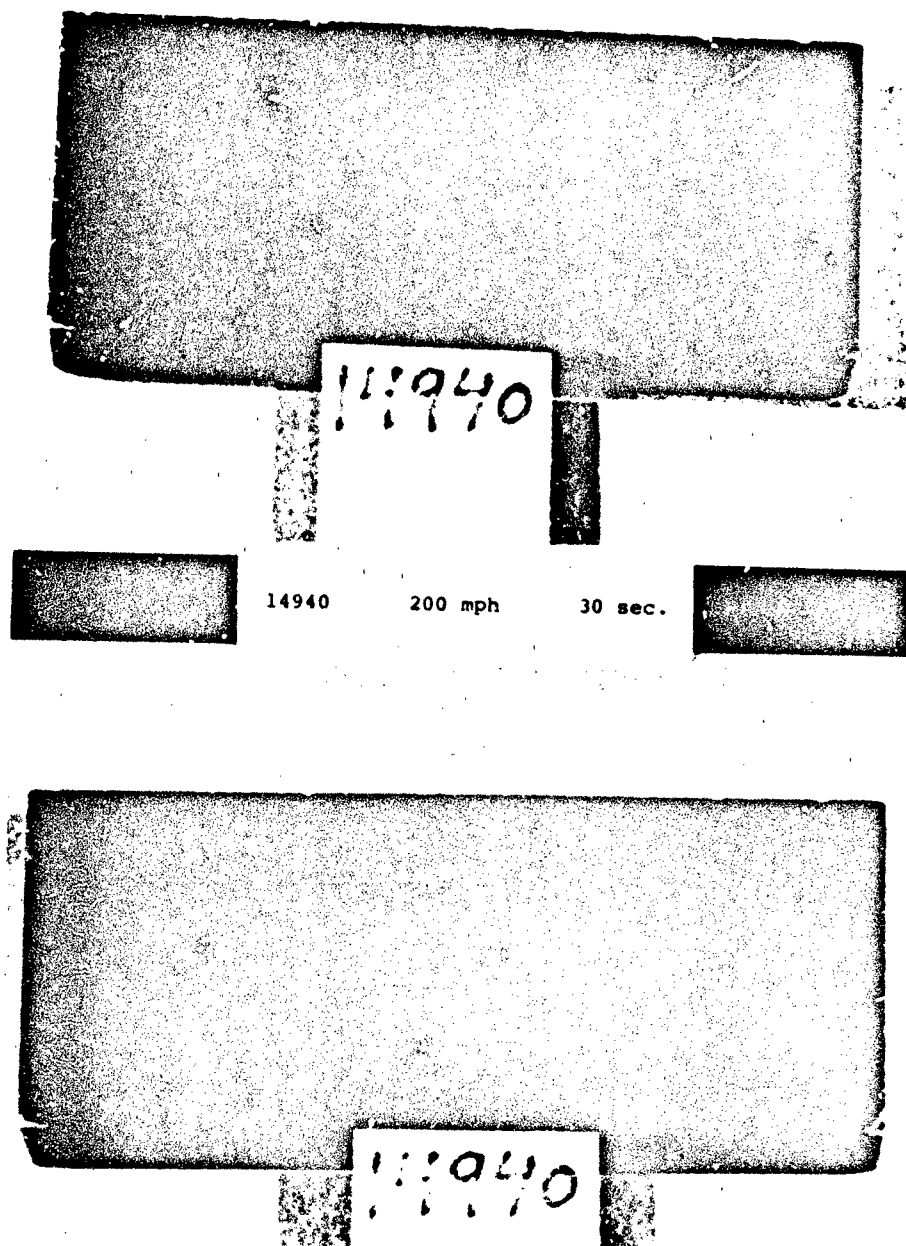
Fig. 5. Pre- and post exposure, FRCI-20-20 with standard RCG ceramic coating, showing subsurface fractures after 30 sec exposure at 200 mph

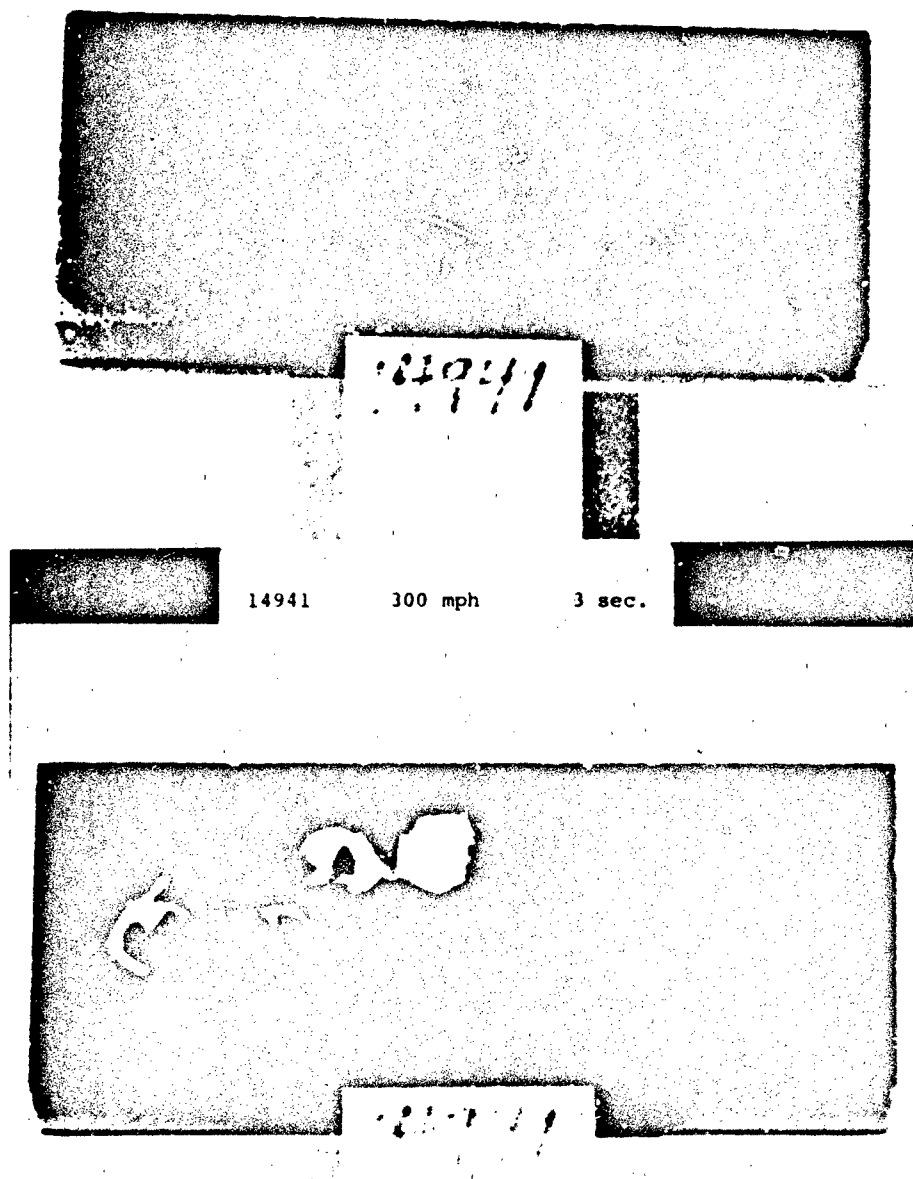
Fig. 6. Pre- and post exposure, FRCI-20-20 with standard RCG ceramic coating, showing damage after 3 sec exposure at 300 mph

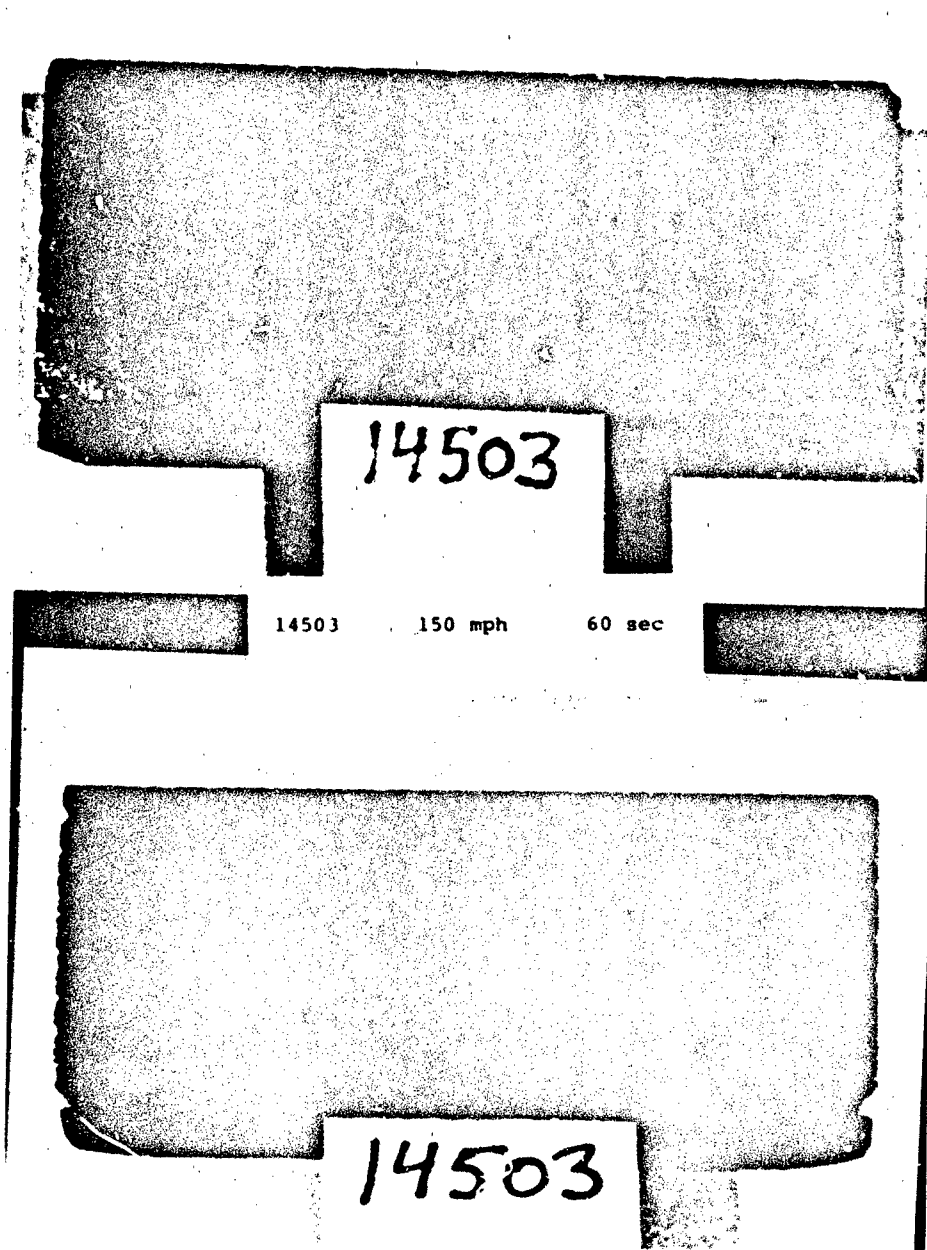
Fig. 7. Pre- and post exposure, LI-2200 with standard RCG ceramic coating, showing star-shaped crack after 60 sec exposure at 150 mph

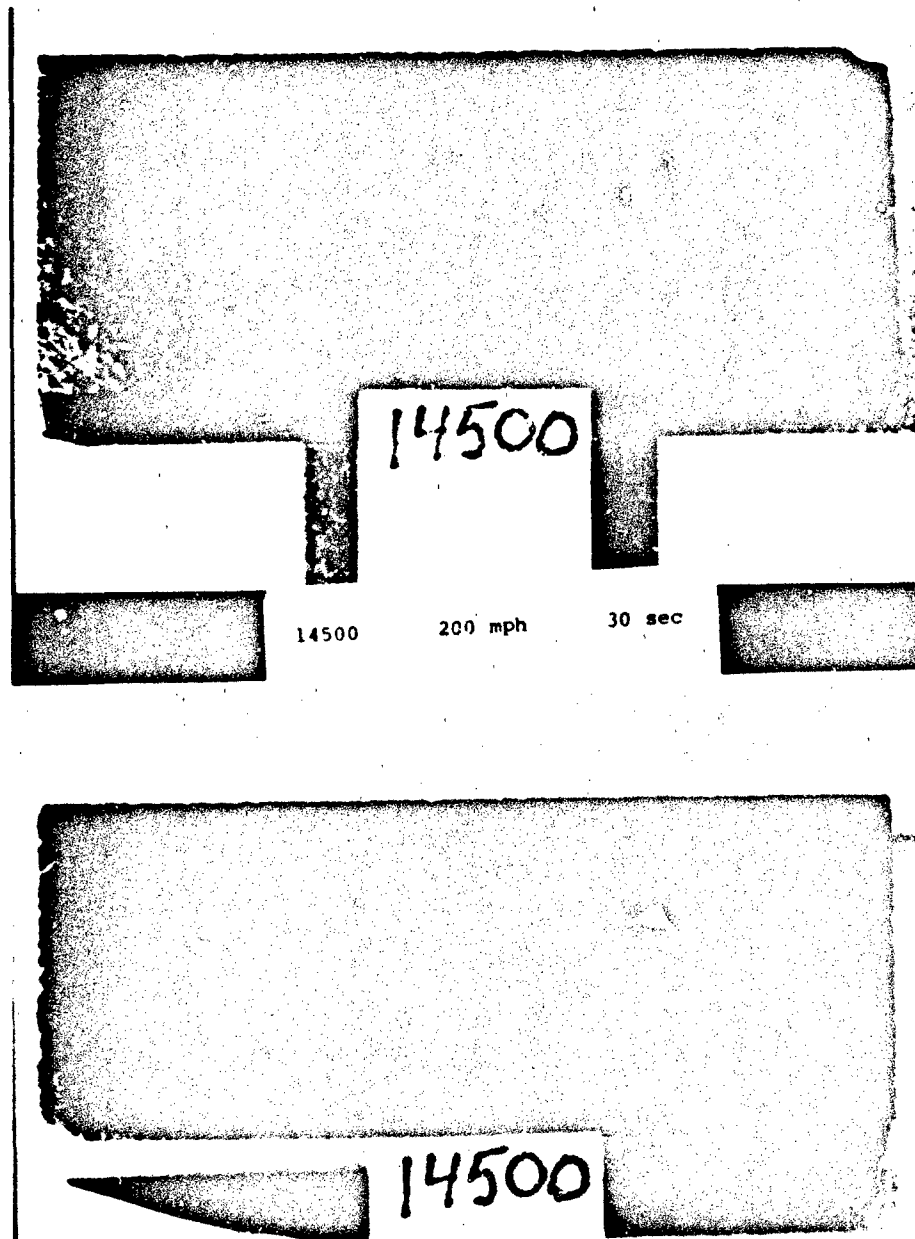
Fig. 8. Pre- and post exposure, LI-2200 with standard RCG ceramic coating, showing damage after 30 sec exposure at 200 mph

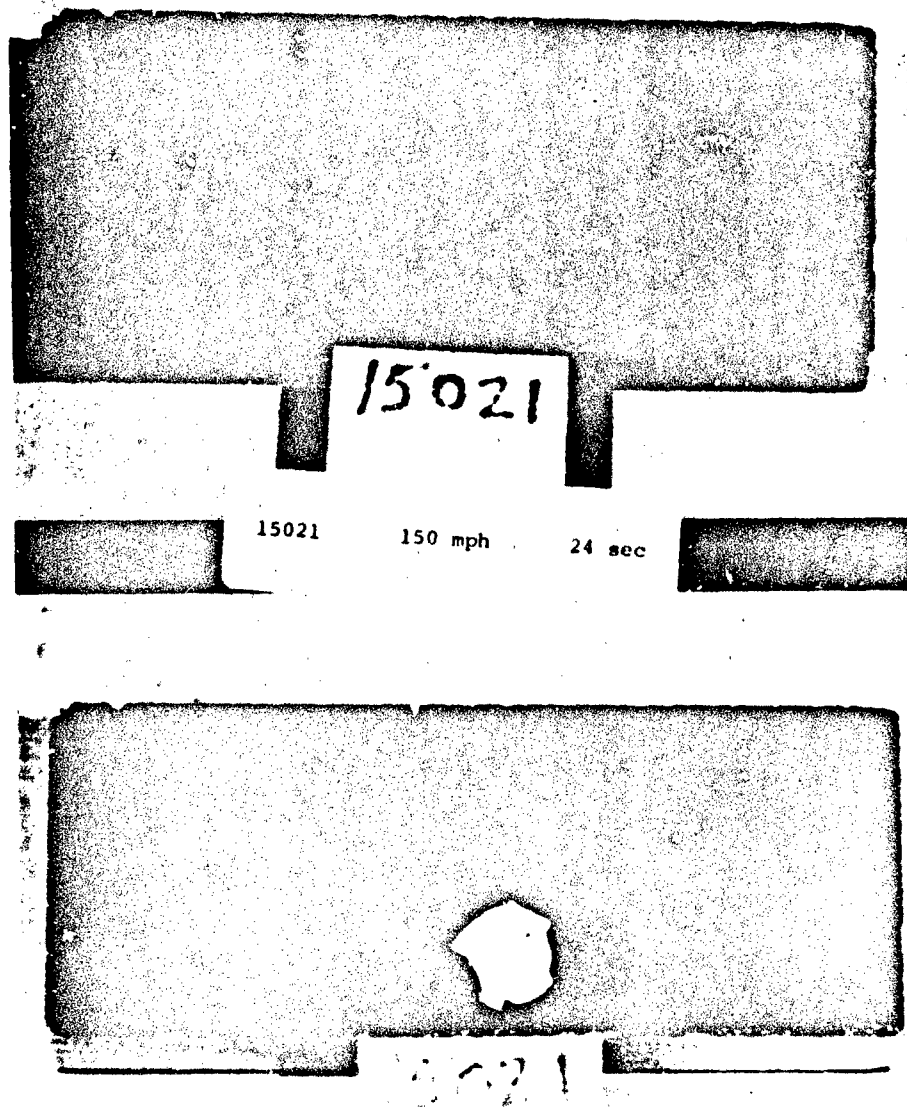
Fig. 9. Pre- and post exposure, FRCI-20-12 with standard RCG ceramic coating, showing surface cracks and loss of coating segment after 24 sec exposure at 150 mph

for a 30 sec duration would be expected at slightly below 150 mph. On the other hand, the FRCI-20-12 samples with twice the standard RCG coating thickness performed as well or slightly better than the FRCI-20-20 with standard coating thickness. At 200 mph, isolated fractures were found after 60 sec exposure time or longer in the case of FRCI-20-12 (Figure 10), whereas damage occurred within 30 sec in the case of the FRCI-20-20 with standard coating thickness.

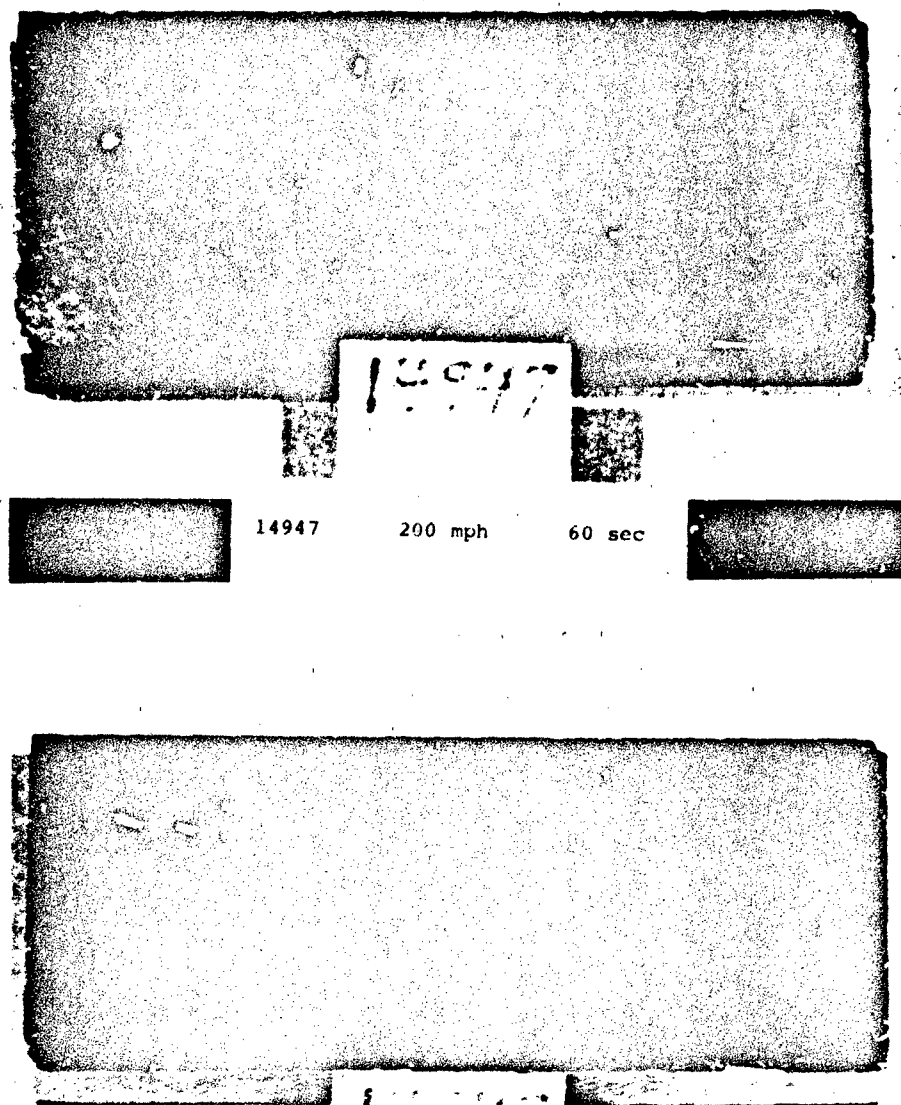
Fig. 10. Pre- and post exposure, FRCI-20-12 with twice standard thickness RCG ceramic coating, showing one subsurface fracture after 60 sec exposure at 200 mph

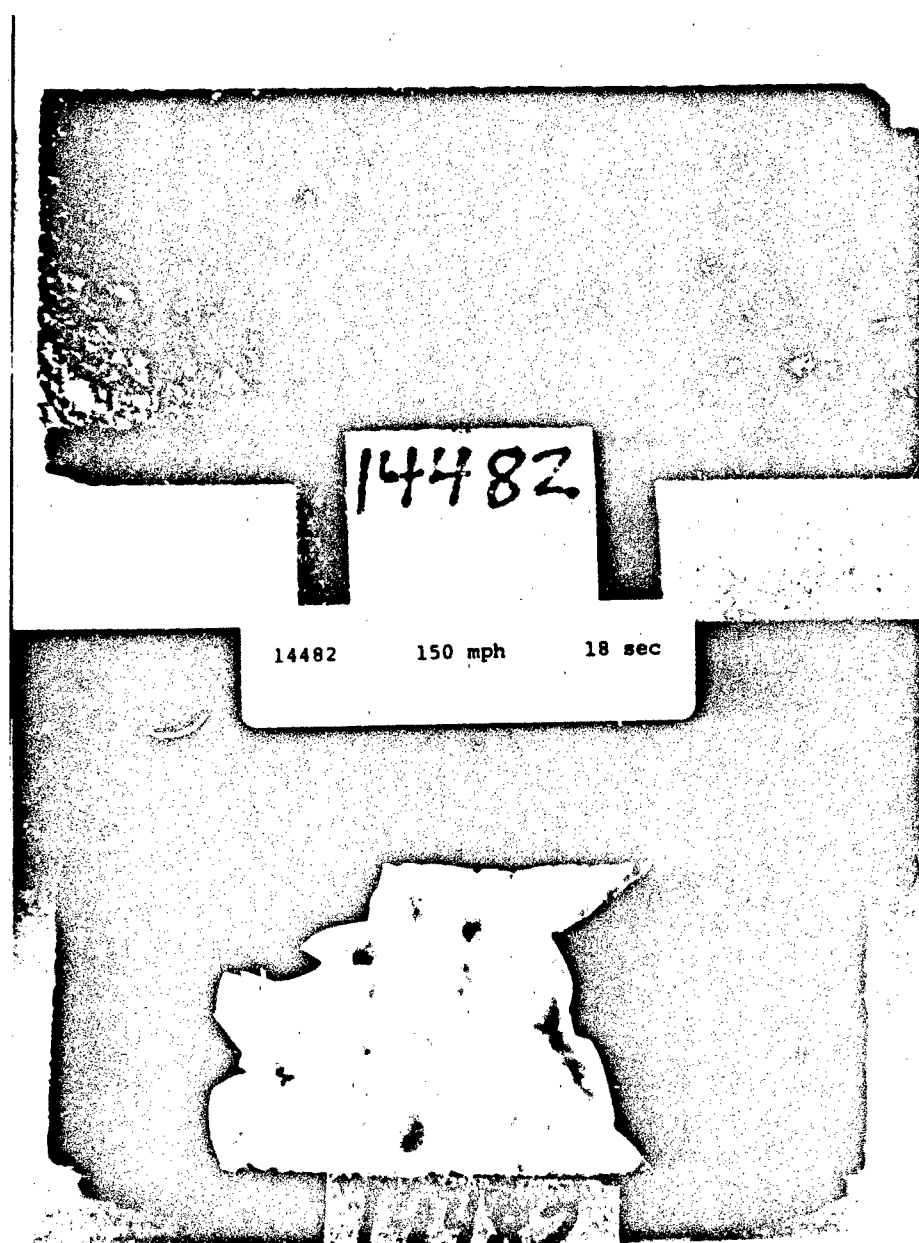
Fig. 11. Pre- and post exposure, LI-900 with standard RCG ceramic coating, showing ceramic coating loss and tile erosion after 18 sec exposure at 150 mph

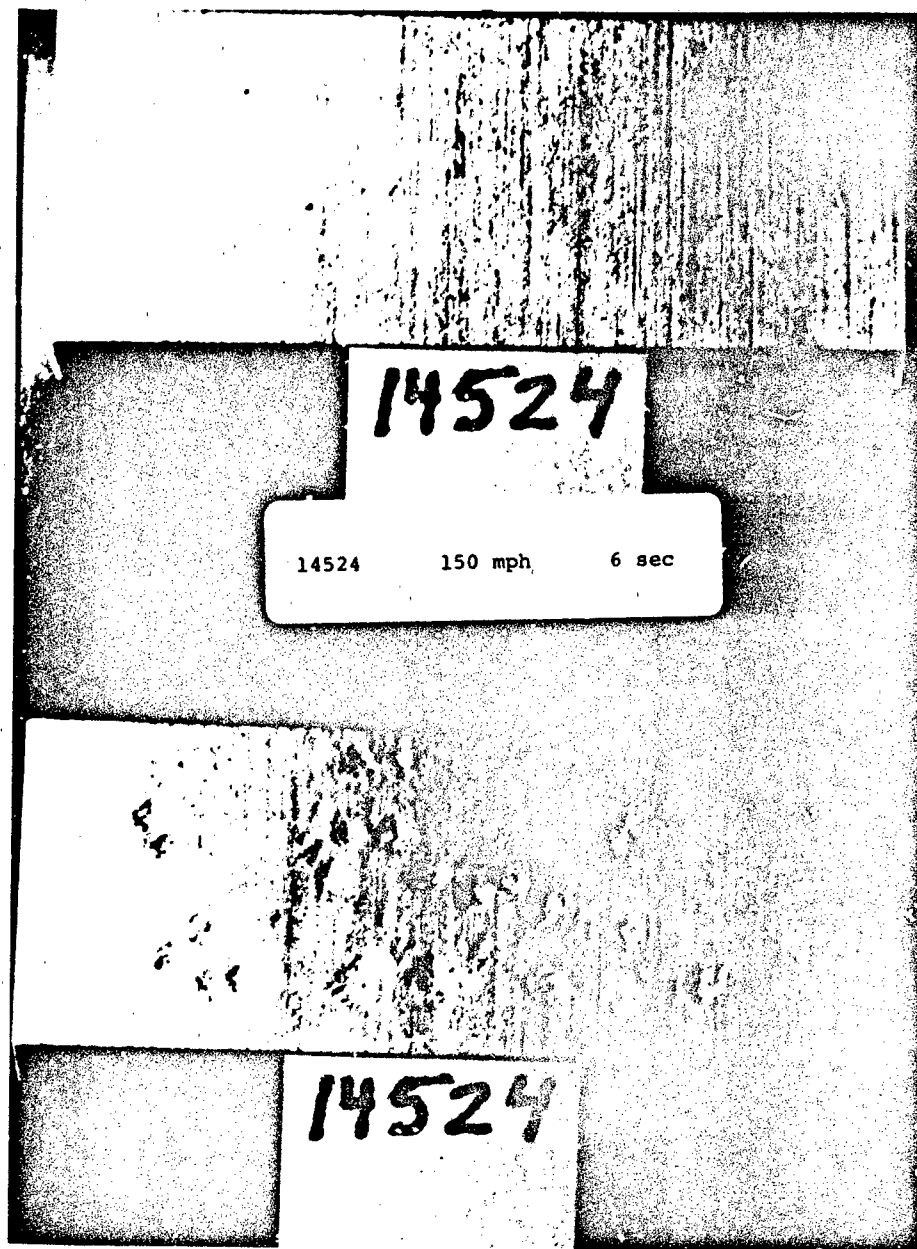
All of the uncoated tile test articles were damaged by surface pitting and cratering at 150 mph test speeds. In the case of the bare waterproofed FRCI-20-20, the onset of surface pitting occurred 6 sec into the test run (Figure 12). Pitting was noted at around 9 sec into the 150 mph run of the bare, unwaterproofed and filled with water FRCI-20-20 samples. However, the accuracy within which these times can be determined is such that sample performance must be considered comparable between these two types of samples for this material. The bare, waterproofed LI-2200 material was pitted within 3 sec of exposure at 150 mph and the extent of the pitting appeared somewhat greater than that for the FRCI-20-20, which was exposed slightly longer (6 to 12 sec versus 3 sec). Surface pitting of the bare, waterproofed FRCI-40-20

Fig. 12. Pre- and post exposure, FRCI-20-20, showing cratering after 6 sec exposure at 150 mph

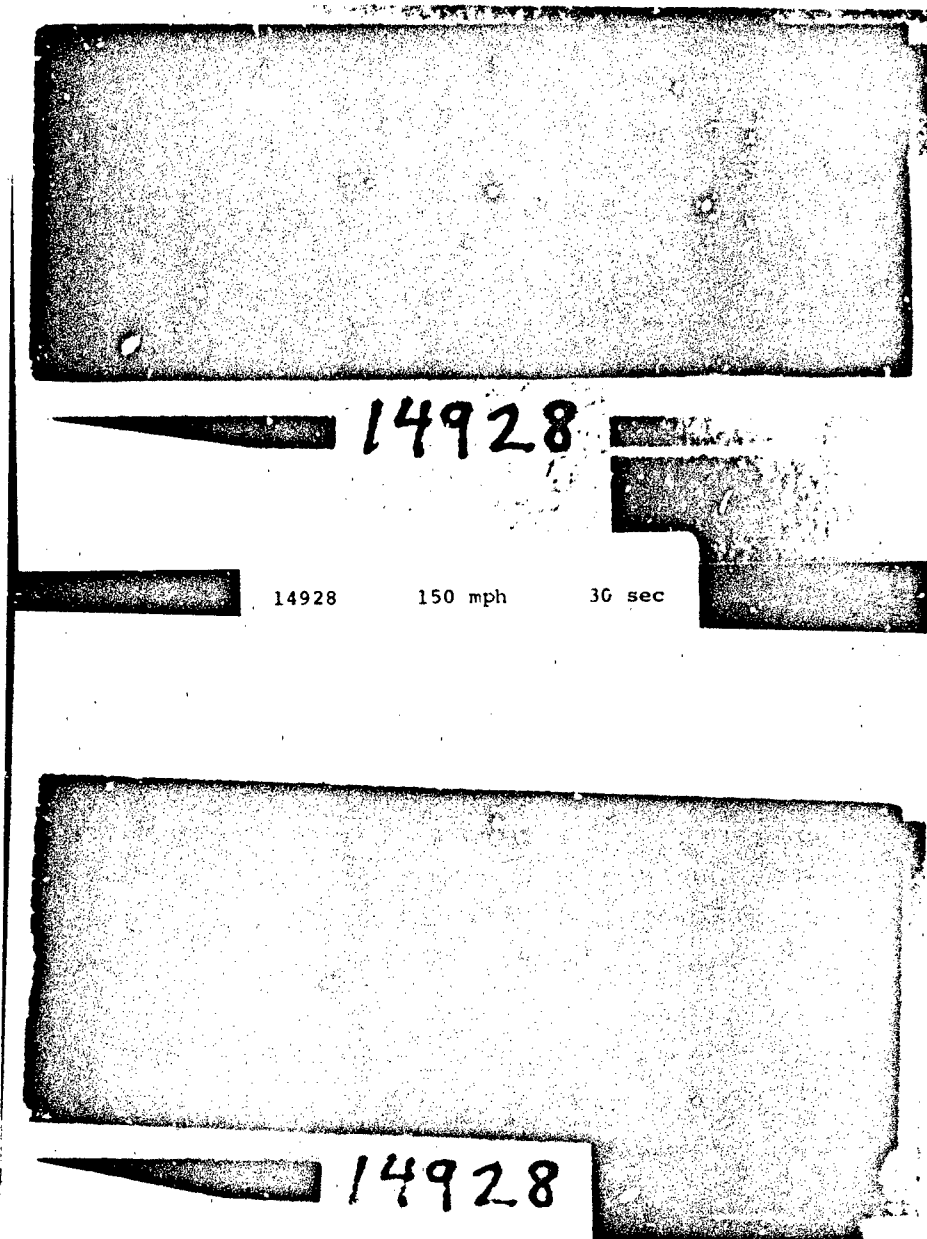
Fig. 13. Pre- and post exposure, FRCI-40-20 with 0.046 lb/ft^2 SiC (CVD) coating, showing cratering after 30 sec exposure at 150 mph

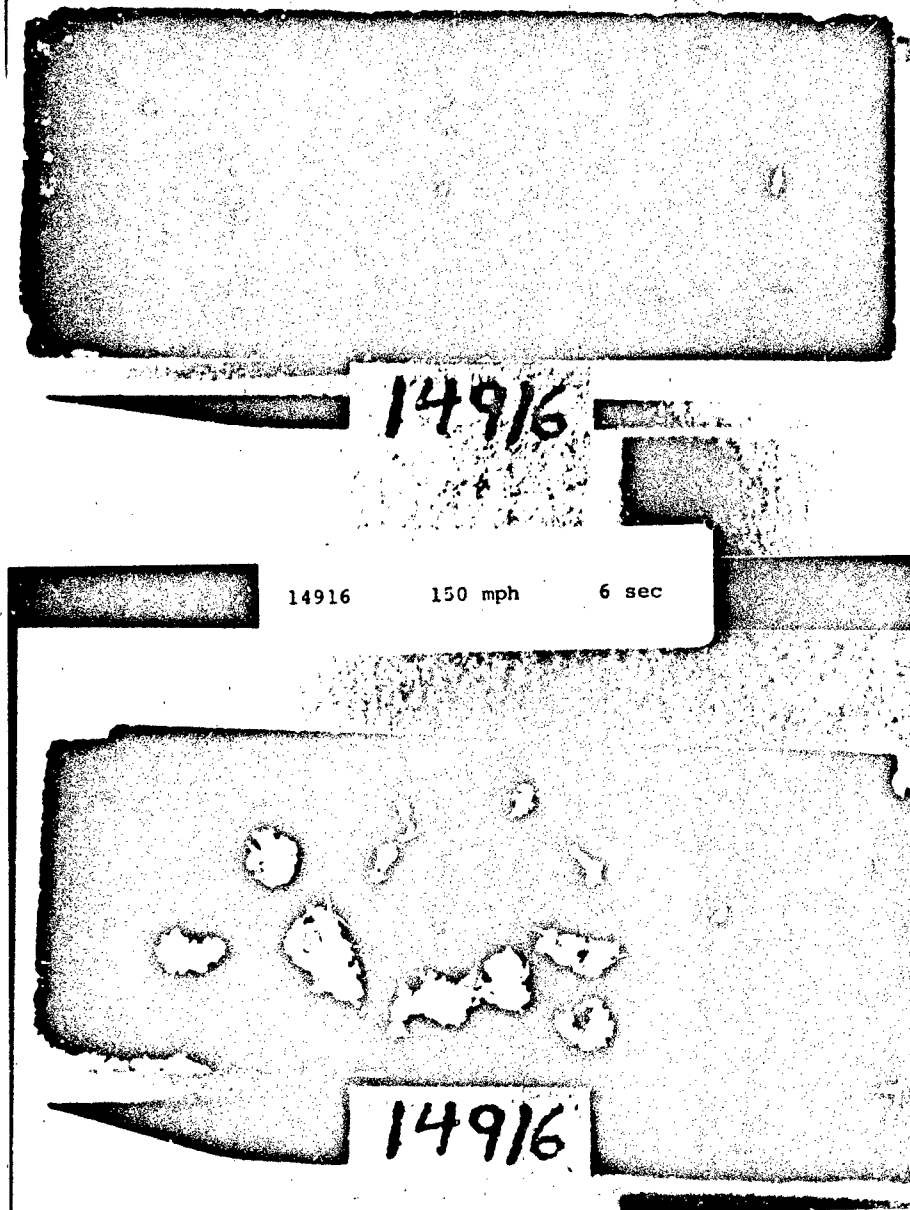
Fig. 14. Pre- and post exposure, Li-2200 with 0.023 lb/ft^2 SiC (CVD) coating, showing cratering and tile erosion after 6 sec exposure at 150 mph

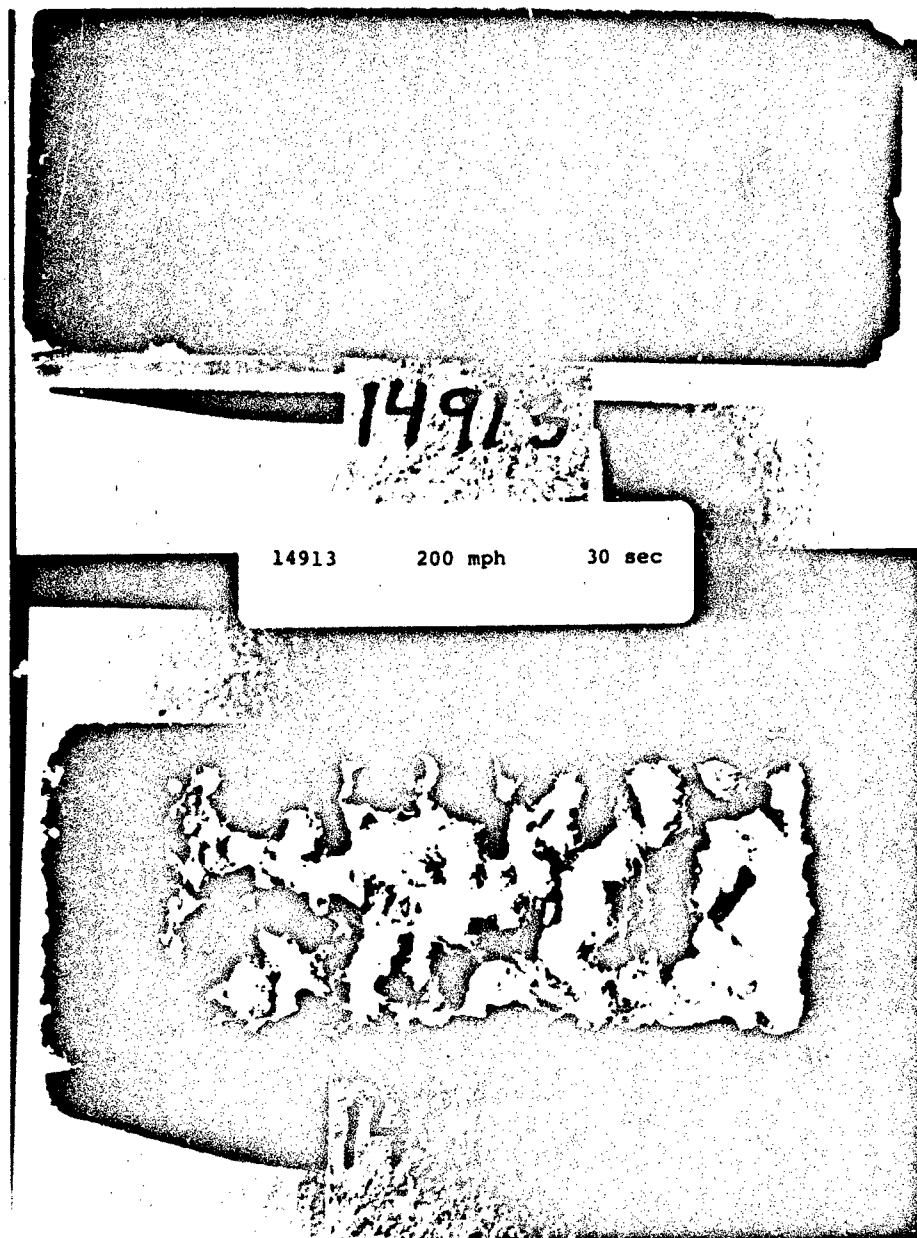
Fig. 15. Pre- and post exposure, LI-2200 with 0.023 lb/ft^2 SiC (CVD) coating, showing coating loss and tile erosion after 30 sec at 200 mph
